Case study – 32 inch glycol still column

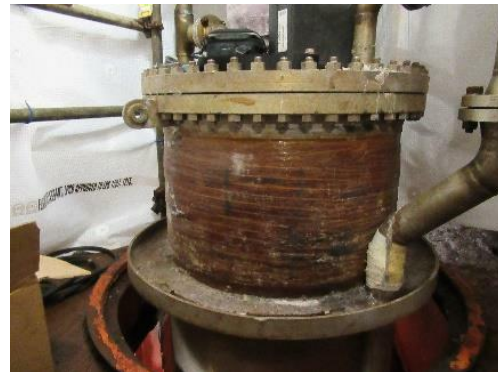
A 32 inch line off a glycol still column was suffering from external corrosion. A previous composite repair had been applied and reached the end of its design life. It was proposed to use a Futurewrap composite repair over the existing repair to reinstate the integrity of the pipework.

Initial condition of pipework

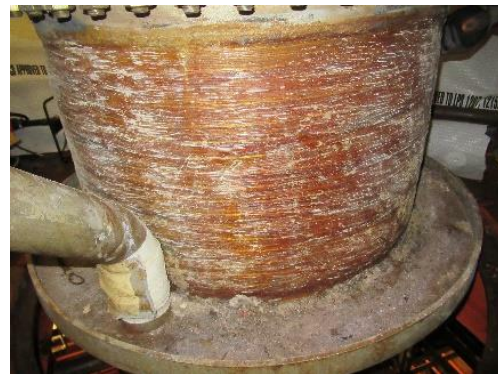
After surface preparation

The installation steps are shown in the photographs. The pipework was depressurised. The surface preparation was to ST2. Heat blankets were used to post cure the repair. Full QA/QC measurements were made to demonstrate that the Futurewrap repair was applied in accordance with ISO 24817.

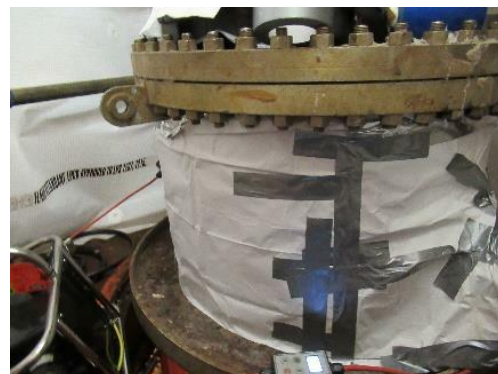
During repair application

The design of the Futurewrap repair was according to ISO 24817. The design approach was for pipework strengthening and leak sealing (at edges of the composite repair). The design parameters were; internal pressure 3.5 bar, temperature 230°C, design lifetime 15 years, slot through wall defect length of 25 mm. The repair design resulted in a thickness of 5 mm (4 layers) of Futurewrap Carbon/HT composite repair with an axial length of 460 mm.

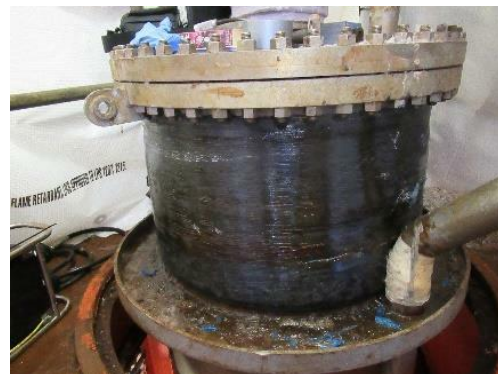
Completed repair

A 32 inch line with an out of date composite repair was repaired using Futurewrap Carbon/HT composite repair. The repair was completed within 6 days allowing the pipework to be re-pressurised returning the pipework to its original integrity.
