Case study – 36 inch produced water caisson (upper section)

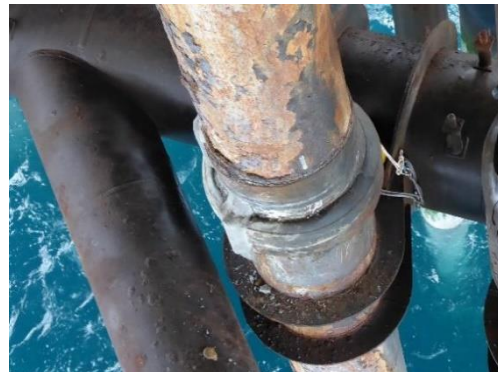
The upper section of a 36 inch produced water caisson was suffering from external corrosion. It was proposed to use a Futurewrap composite repair to reinstate the strength and therefore integrity of the caisson as the remaining wall thickness was down to 2 mm in some locations.

Initial condition of pipework

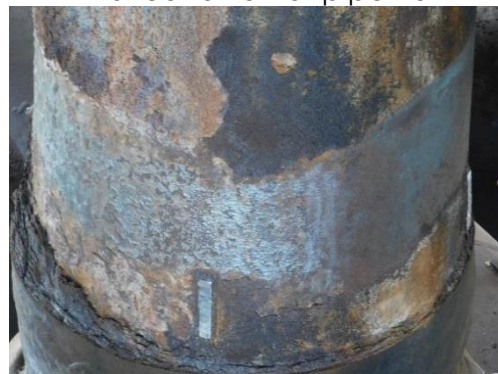
After surface preparation

The installation steps are shown in the photographs. The caisson was depressurised. The surface preparation was to ST3 in 1 meter bands. Full QA/QC measurements were made to demonstrate that the Futurewrap repair was applied in accordance with ISO 24817. The repair was applied off ropes

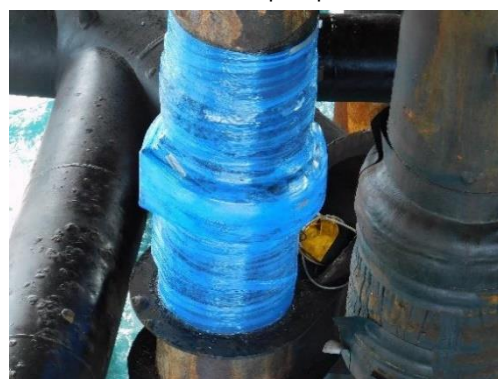
During installation

The design of the Futurewrap repair was according to ISO 24817. The design approach was to strengthen and locally leak seal. The design parameters were; internal pressure 1.5 bar, axial load 194 kN, bending moment 176.8 kNm, temperature 60°C, design lifetime 20 years. The repair design resulted in a thickness of 6.2 mm (4 layers) of Futurewrap Carbon/Aquasplash composite repair with an axial length of 2300 mm.

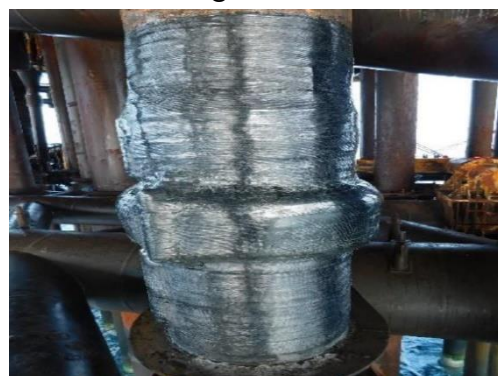
Final cured repair

A 36 inch section of produced water caisson was repaired using Futurewrap Carbon/Aquasplash composite repair. The repair was completed within 14 days allowing the pipework to be re-pressurised and returning it to its original integrity.
