Case study – 6 inch vessel stubs

Integrity issue

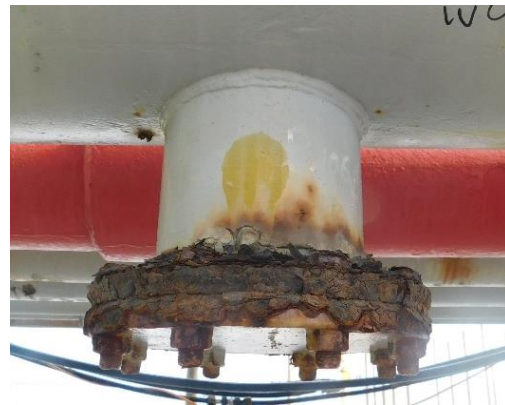
Two 6 inch blanked off stubs at the 6 o'clock position of a gas header vessel on a FPSO off the west coast of Africa were suffering from external corrosion. It was proposed to use a Futurewrap composite repair to reinstate the strength and seal the potential threat of a through wall defect.

Initial condition of stub

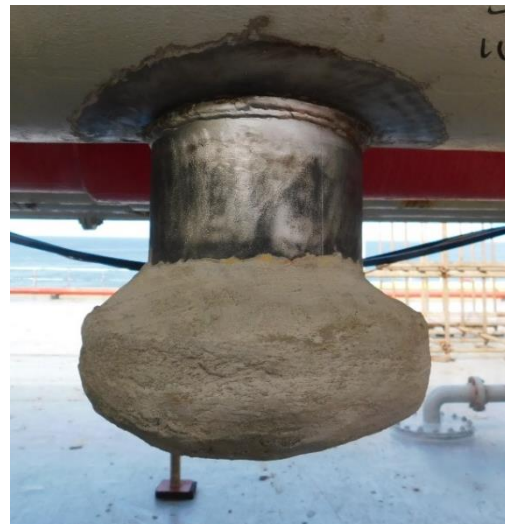
After profiling

The installation steps are shown in the photographs. The surface of the stubs was bristle blasted to ST3. The flanges were then profiled with filler, followed by application of the 6 layers of Futurewrap Glass/LT repair. Full QA/QC measurements were made to demonstrate that the Futurewrap repair was applied in accordance with ISO 24817.

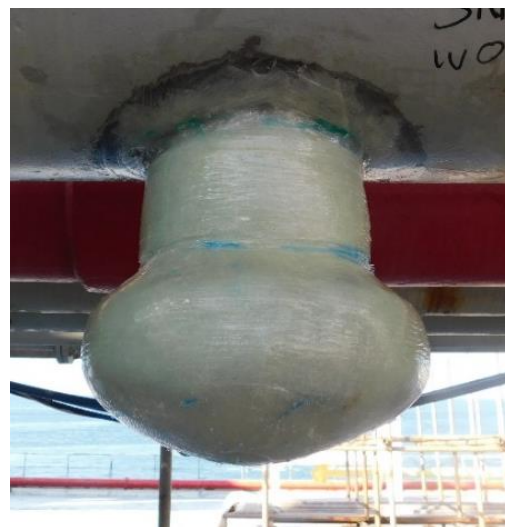
Final cured repair

The design of the Futurewrap repair was according to ISO 24817. The design approach was to strengthen and locally leak seal. The design parameters were; internal pressure 0.5 bar, temperature 40°C, design lifetime 2 years. The repair design resulted in a thickness of 5 mm (6 layers) of Futurewrap Glass/LT composite repair with an axial length of 550 mm.

Two 6 inch blanked off vessel stubs suffering external corrosion were repaired using a Futurewrap Glass/LT composite repair. The repairs were completed within 3 days allowing the header system to be returned to its original integrity.
