Case study – 16 inch crude oil separator line

Integrity issue

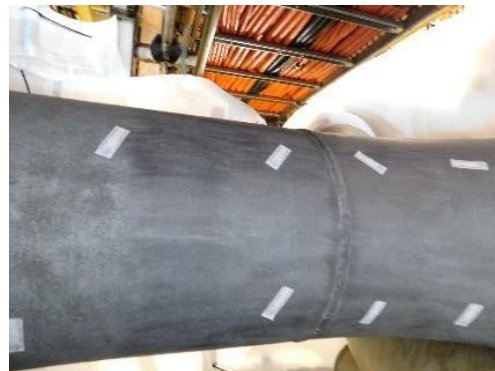
A 16 inch crude oil separator line was suffering from internal corrosion. The measured remaining wall thickness was 3.4 mm. It was estimated that the corrosion rate was 0.6 mm/year. The repair was designed for a 2 year life where it was assumed therefore that the remaining wall thickness at end of life of the repair was 2.2 mm. It was proposed to use a Futurewrap composite repair to reinstate the integrity of the pipework.

Initial condition of pipework

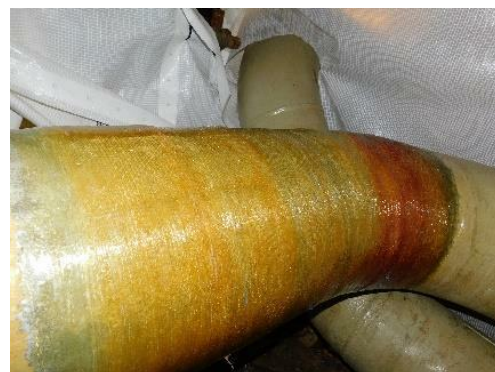
Completed repair

The design of the Futurewrap repair was according to ISO 24817. The design approach was for pipework strengthening only with allowance for the remaining wall thickness of the pipework. The design parameters were; internal pressure 12.8 bar, temperature 230°C, design lifetime 2 years. The repair design resulted in a thickness of 5 mm (6 layers) of Futurewrap Glass/HT with an axial length of repair of 1020 mm.

The installation steps are shown in the photographs. The pipework was depressurised. The surface preparation was to ST3. Full QA/QC measurements were made to demonstrate that the Futurewrap repair was applied in accordance with ISO 24817.

A 16 inch crude oil separator line suffering internal corrosion was repaired using a Futurewrap Glass/HT composite repair. The repair was completed within 3 days allowing the pipework to be re-pressurised with the pipework returned to its original integrity.
