Case study – 16 inch crude oil separator line

Integrity issue

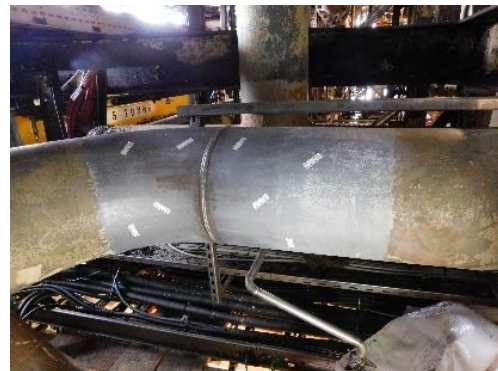
A 16 inch crude oil separator line was suffering from internal corrosion. The measured remaining wall thickness was 3.4 mm. It was estimated that the corrosion rate was 0.6 mm/year. The repair was designed for a 2 year life where it was assumed therefore that the remaining wall thickness at end of life of the repair was 2.2 mm. It was proposed to use a Futurewrap composite repair to reinstate the integrity of the pipework.

Initial condition of pipework

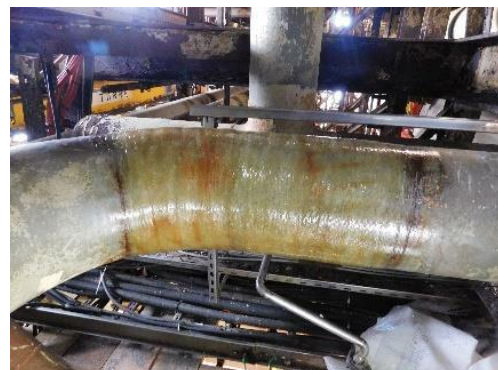
Completed repair

The design of the Futurewrap repair was according to ISO 24817. The design approach was for pipework strengthening only with allowance for the remaining wall thickness of the pipework. The design parameters were; internal pressure 12.8 bar, temperature 230°C, design lifetime 2 years. The repair design resulted in a thickness of 5 mm (6 layers) of Futurewrap Glass/HT with an axial length of repair of 1120 mm.

The installation steps are shown in the photographs. The pipework was depressurised. The surface preparation was to ST3. Full QA/QC measurements were made to demonstrate that the Futurewrap repair was applied in accordance with ISO 24817.

A 16 inch crude oil separator line suffering internal corrosion was repaired using a Futurewrap Glass/HT composite repair. The repair was completed within 3 days allowing the pipework to be re-pressurised with the pipework returned to its original integrity.
