Case study – 30 inch straight

Integrity issue

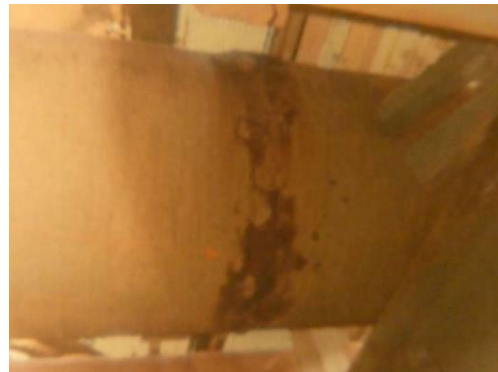
The weld of a 30 inch straight section of pipework containing cooling water was suffering from severe external corrosion. The corrosion had reduced the wall thickness such that the weld was weeping. It was proposed to use a Futurewrap composite repair to reinstate the integrity of the pipework.

Initial condition of pipework

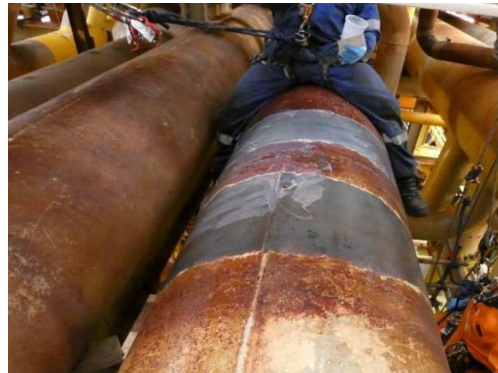
After surface preparation

The installation steps are shown in the photographs. The pipework was depressurised. The surface preparation was to ST3. Full QA/QC measurements were made to demonstrate that the Futurewrap repair was applied in accordance with ISO 24817 despite the limited access.

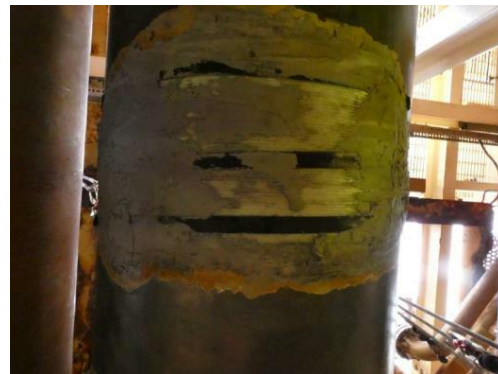
During repair application

The design of the Futurewrap repair was according to ISO 24817. The design approach was for pipework strengthening and leak sealing accounting for the limited landing area caused by the weld neck flange. The design parameters were; internal pressure 12.8 bar, temperature 93°C, design lifetime 10 years, through wall defect. The repair design resulted in a thickness of 16.7 mm (20 layers) of Futurewrap Glass/LT composite repair with an axial length of 810 mm.

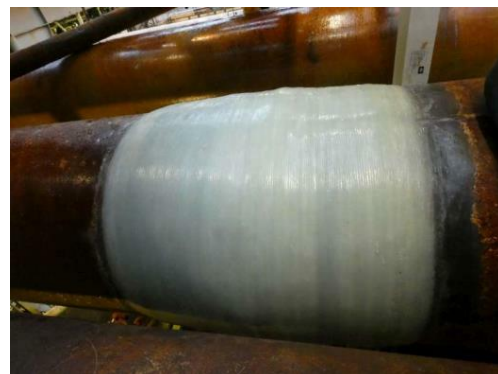
Completed repair

A 30 inch cooling water tee/header suffering severe external corrosion was repaired using Futurewrap Glass/LT composite repair. The repair was completed within 11 days allowing the pipework to be re-pressurised returning the pipework to its original integrity.
