Case study – 42 inch hot air line

Integrity issue

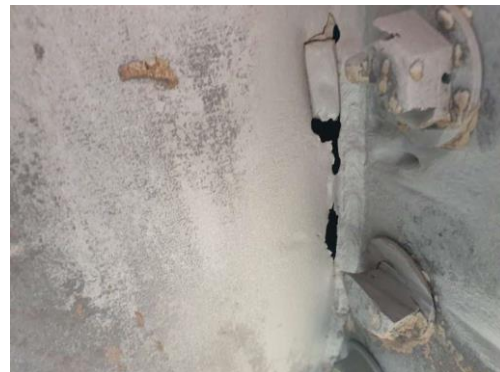
A 42 inch hot air line was suffering from both external corrosion. Close to a flange face over time the external corrosion had created a through wall defect. A long term solution was sought and therefore an engineered Futurewrap repair was proposed. To reinstate the integrity of this section of this elevated 42 inch line, it was proposed to use a Futurewrap Glass/HT composite repair.

Initial status of pipework

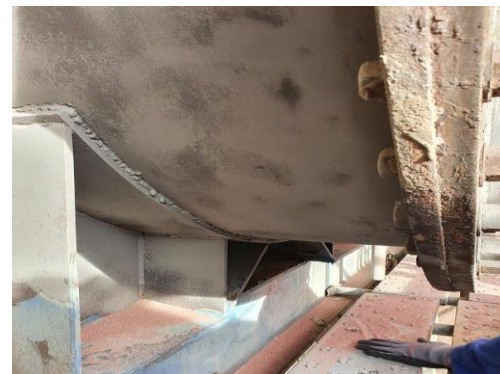
After surface preparation

The installation steps are shown in the photographs. The repair was applied off ropes as the pipework is elevated. The surface preparation was to Sa2.5. Full QA/QC measurements were made to demonstrate that the Futurewrap repair was applied in accordance with ISO 24817.

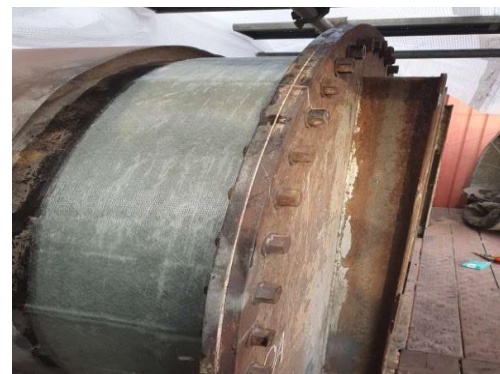
During repair application

The design of the Futurewrap Glass/HT repair was to strengthen the pipework and seal the through wall defect. The design parameters were; pressure 3 bar, temperature 140°C, design lifetime 20 years. It was assumed that the composite repair would carry all the applied load. The repair design resulted in a thickness of 4.8 mm (6 layers) of Futurewrap Glass/HT composite repair with an axial length of 300 mm.

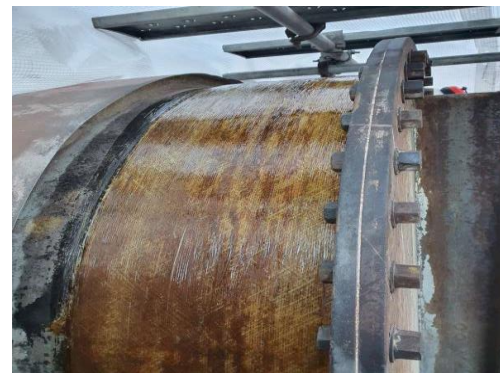
Completed repair

A 42 inch air line suffering external corrosion was repaired using Futurewrap Glass/HT composite repair. The repair was completed within 1 days reinstating the integrity of the pipework.
